TEST REPORT

Report No. : TH30189/2017

Product Description: SEAT POST
Style/Item No.: SP12 NCX31.6*400
Sample Quantity: 1 pc of seatpost

Test Requested: For compliance with Clause 4.16.6.1.2 and Clause 4.16.6.2.2 of ISO 4210-2:2015 Cycles — Safety requirements for bicycles — Part 2: Requirements for city and trekking, young adult, mountain and racing bicycles.

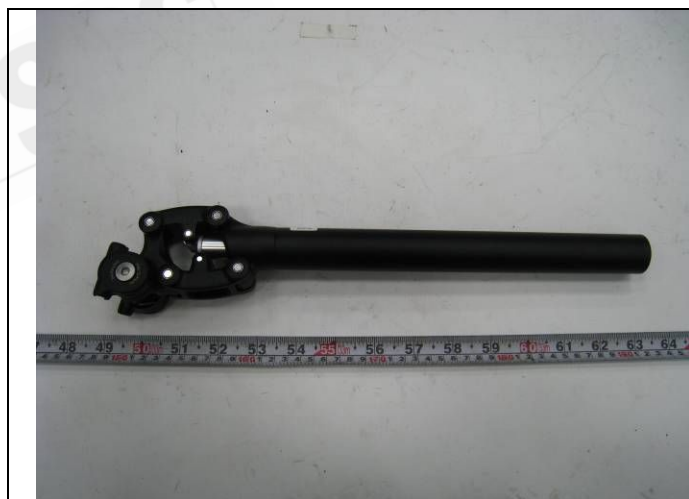
Photo "A" Appearance of sample

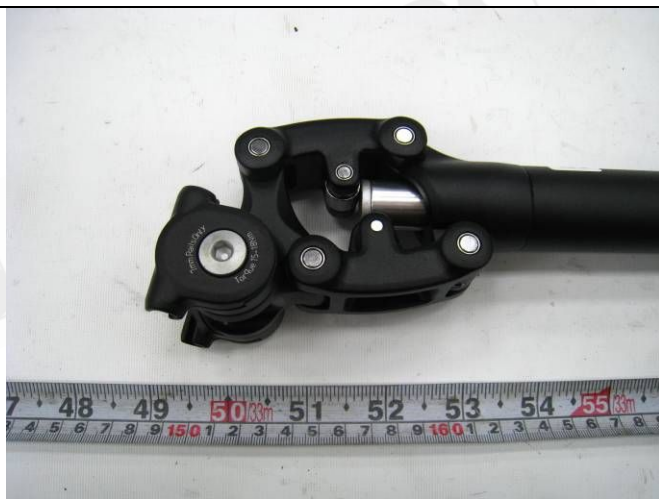
Photo "B" Appearance of sample

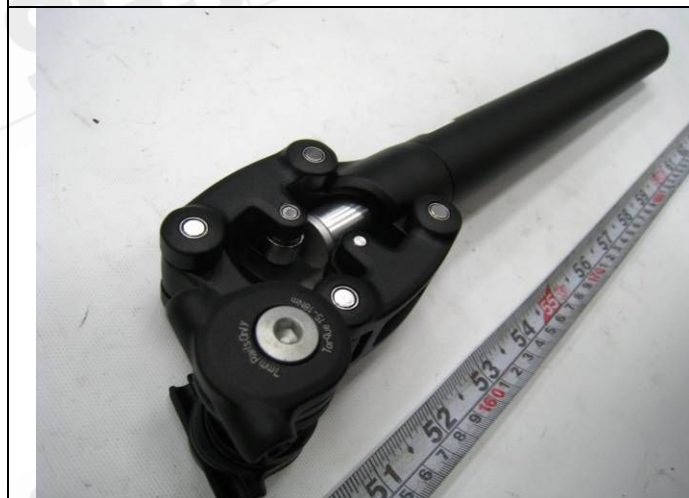
Photo "C" Appearance of sample
